**Flood Control Project Maintenance  
Levee Inspections**  
**LMA District Cover Sheet**  
**Spring 2019 Levee Inspection Results**

**Reclamation District No. 0827 Elkhorn**

**Levee Inspection Report By Mile - Spring 2019**

Waterway	Bank	Unit Miles	Inspection Start/End	Inspector
Unit No. 01 Sacramento River	Right	1.34	03/07/2019 03/07/2019	Zach Jojola

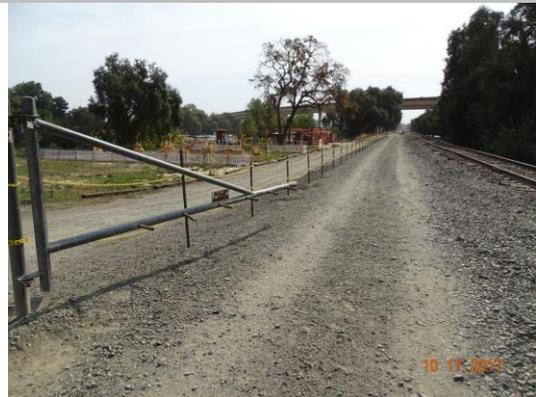
Photo 1 of 1 : SP\_2019\_RD0827\_187\_16\_20190304\_00012.jpg

LM Start	<b>0.03</b>	Rating **	M	Issue No.	<b>16</b>
LM End	<b>0.15</b>	Issue Type +	En	Location *	CR
Category	Earthen Levee		GPS Latitude/Longitude		
			Start	End	
Item	Encroachments		38.674881°	38.673668°	
			-121.630109°	-121.628490°	
DWR ID	DWR_RD0827_01_f_2017_16				
Comment Code					
FE : Fence					
Inspector Comment					
Fence installed by adjacent tourism company. Submitted a FIR to the CVFPB.

View of fence on crown. Fall 2017.

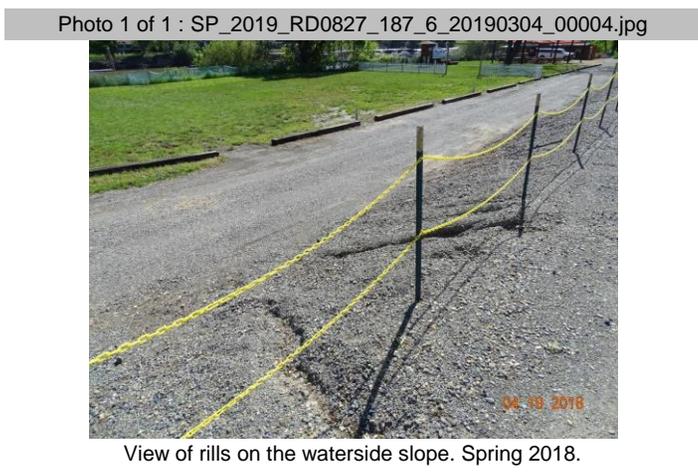
LM Start	<b>0.04</b>	Rating **	A/W	Issue No.	<b>6</b>
LM End	<b>0.04</b>	Issue Type +	Ma	Location *	WS
Category	Earthen Levee		GPS Latitude/Longitude		
			Start	End	
Item	Erosion / Bank Caving		38.674833 °	38.674833 °	
			-121.630039 °	-121.630039 °	
DWR ID	DWR_RD0827_01_s_2018_6				
Comment Code					
E1 : Note and monitor erosion site.					
Inspector Comment					
Small rills beginning to form on waterside slope. Recommend monitoring.

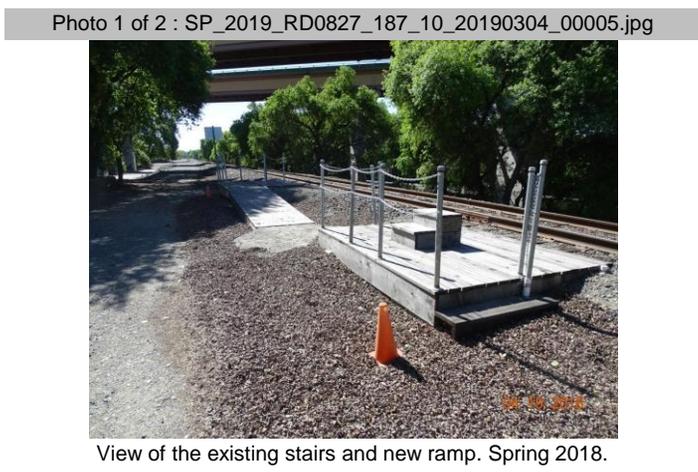
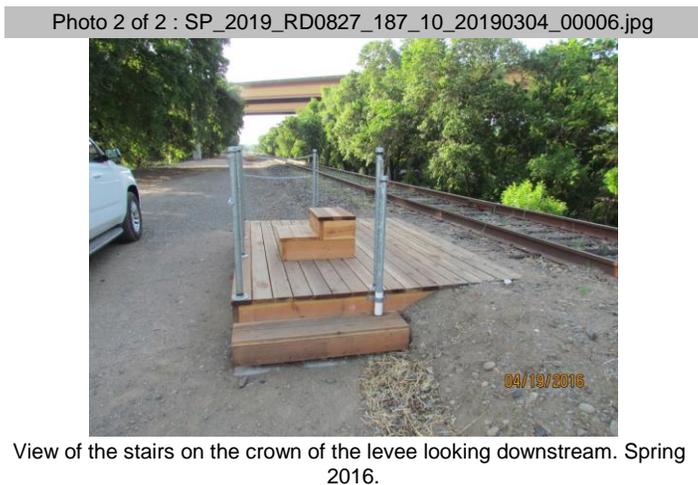
LM Start	<b>0.14</b>	Rating **	M	Issue No.	<b>10</b>
LM End	<b>0.14</b>	Issue Type +	En	Location *	CR
Category	Earthen Levee		GPS Latitude/Longitude		
			Start	End	
Item	Encroachments		38.673767 °	38.673767 °	
			-121.628593 °	-121.628593 °	
DWR ID	DWR_RD0827_01_f_2018_10				
Comment Code					
ST : Stairway					
Inspector Comment					
Railroad has put steps on the crown for the tourist train from the West City of Sac water plant. Stairs are not permitted and was placed Spring 2016. The railroad has added a wheelchair access ramp. Subitted a FIR to the CVFPB.

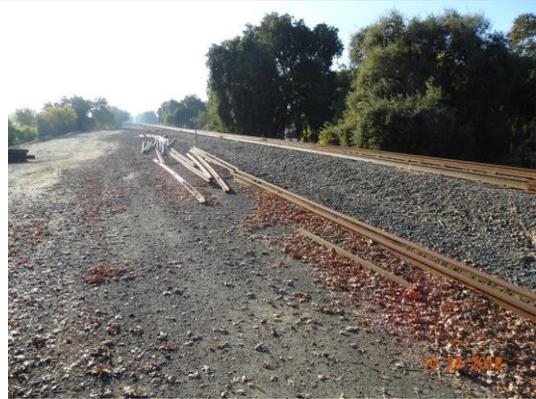
Photo 1 of 2 : SP\_2019\_RD0827\_187\_12\_20190304\_00007.jpg

LM Start	<b>0.24</b>	Rating **	M	Issue No.	<b>12</b>
LM End	<b>0.58</b>	Issue Type +	En	Location *	CR
Category	Earthen Levee		GPS Latitude/Longitude		
			Start	End	
Item	Encroachments		38.672749°	38.669200°	
			-121.627333°	-121.622851°	
DWR ID	DWR_RD0827_01_s_2016_12				
Comment Code					
MA : Material					
Inspector Comment					
RR rails and ties on the levee crown.

View of railroad ties on the crown. Fall 2018.

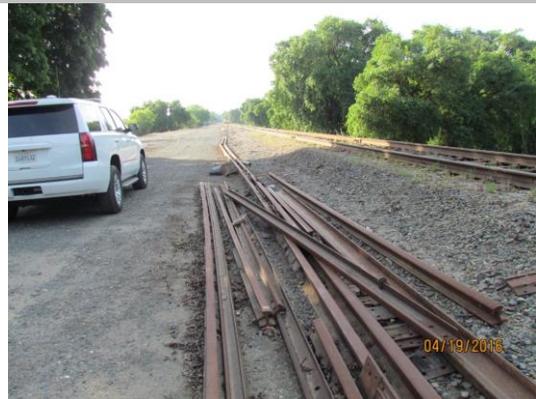
Photo 2 of 2 : SP\_2019\_RD0827\_187\_12\_20190304\_00008.jpg

View of the rails on the crown of the levee looking downstream. Spring 2016.

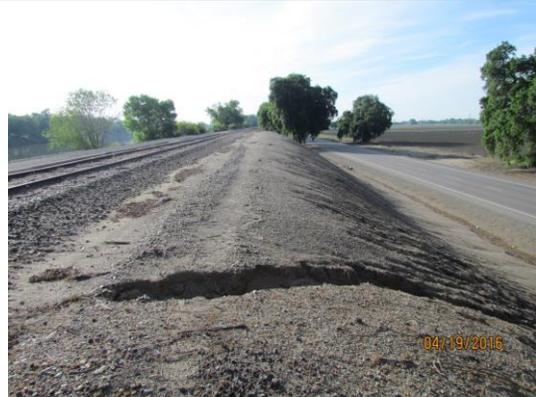
Photo 1 of 2 : SP\_2019\_RD0827\_187\_13\_20190304\_00009.jpg

LM Start	<b>0.51</b>	Rating **	M	Issue No.	<b>13</b>
LM End	<b>0.51</b>	Issue Type +	Ma	Location *	LS
Category	Earthen Levee		GPS Latitude/Longitude		
			Start	End	
Item	Erosion / Bank Caving		38.669929°	38.669929°	
			-121.623776°	-121.623776°	
DWR ID	DWR_RD0827_01_s_2016_13				
Comment Code					
E2 : Schedule repair of erosion site prior to the next inspection.					
Inspector Comment					
Rills caused by rain.

View of the erosion on the landward side of the levee looking downstream. Spring 2016.

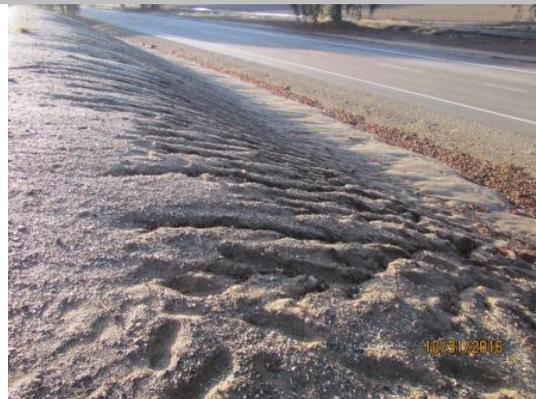
Photo 2 of 2 : SP\_2019\_RD0827\_187\_13\_20190304\_00010.jpg

View of runoff erosion site. LS slope. Fall 2016.

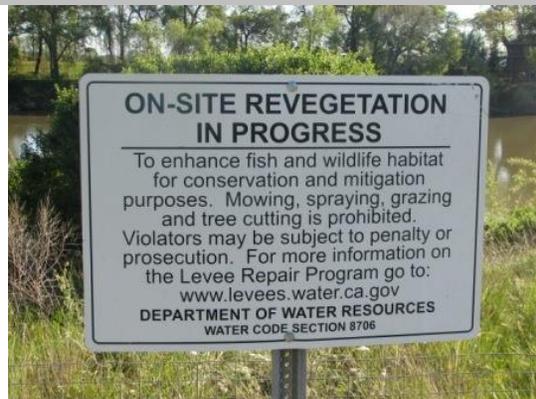
Photo 1 of 2 : SP\_2019\_RD0827\_187\_22\_20190304\_00013.jpg

LM Start	<b>0.61</b>	Rating **	A/W	Issue No.	<b>22</b>
LM End	<b>0.92</b>	Issue Type +	Ma	Location *	WS
Category	Earthen Levee		GPS Latitude/Longitude		
			Start	End	
Item	Vegetation		38.668873°	38.665750°	
			-121.622513°	-121.618523°	
DWR ID	DWR_RD0827_01_s_2012_22				
Comment Code					
V8 : Environmental Requirements.					
Inspector Comment

Revegetation site spring 2012.

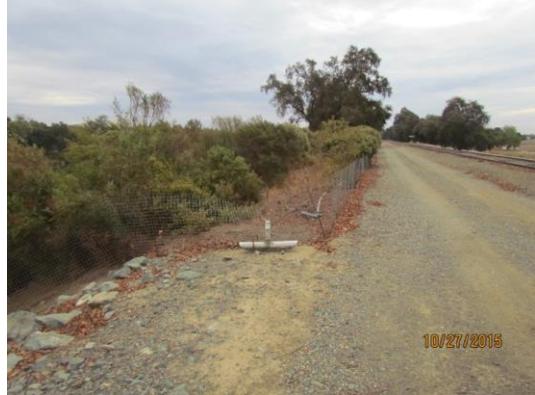
Photo 2 of 2 : SP\_2019\_RD0827\_187\_22\_20190304\_00014.jpg

View of the revegetation site on the waterward side of the levee looking downstream. Fall 2015.

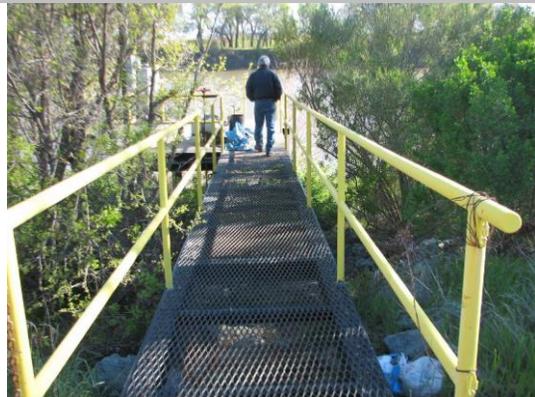
Photo 1 of 3 : UCIP\_SP\_2019\_38983\_59737.jpg

Item	DWR UCIP Field Study			38.667731 °	38.667731 °
				-121.620992 °	-121.620992 °
DWR ID	21147				
Comment Code					
Inspector Comment					
FS_ID:38983 DS_ID:21147 EP_NO: N/A Repair Type: Non-Urgent Crossing Status: Found UCIP Comments: Need to contact owner to obtain additional information for this crossing. This crossing does not match original description listed in desk study. Need to coordinate with owner to obtain permit number authorizing modification. FIELD_STRUCT_DESC: 14-inch (not 16-inch as listed in desk study) pipe through the levee, 10.3 feet below the crown. 10-inch bypass pipe on waterside (WS). Siphon breaker on landside (LS) (not WS) shoulder. Pump on platform (not mounted on 48-inch concrete pipe as described in desk study) on WS bank. Metal (not wooden) walkway to the pump. 3/4-inch conduit through levee at unknown depth. [Additional Reference(s): DWR Levee Logs, 2005] FS Date: 3/18/2014

Platform for pump located on waterward side.

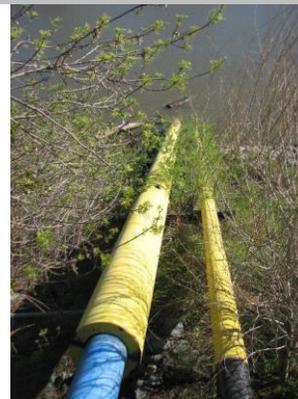
Photo 2 of 3 : UCIP\_SP\_2019\_38983\_59736.jpg

Item	DWR UCIP Field Study			38.667731 °	38.667731 °
				-121.620992 °	-121.620992 °
DWR ID	21147				
Comment Code					
Inspector Comment					
FS_ID:38983 DS_ID:21147 EP_NO: N/A Repair Type: Non-Urgent Crossing Status: Found UCIP Comments: Need to contact owner to obtain additional information for this crossing. This crossing does not match original description listed in desk study. Need to coordinate with owner to obtain permit number authorizing modification. FIELD_STRUCT_DESC: 14-inch (not 16-inch as listed in desk study) pipe through the levee, 10.3 feet below the crown. 10-inch bypass pipe on waterside (WS). Siphon breaker on landside (LS) (not WS) shoulder. Pump on platform (not mounted on 48-inch concrete pipe as described in desk study) on WS bank. Metal (not wooden) walkway to the pump. 3/4-inch conduit through levee at unknown depth. [Additional Reference(s): DWR Levee Logs, 2005] FS Date: 3/18/2014

Pipe visible on waterward side.

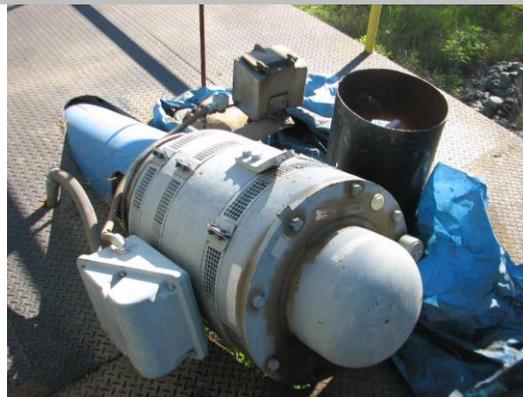
Photo 3 of 3 : UCIP\_SP\_2019\_38983\_59735.jpg

Slant pump located on waterward side.

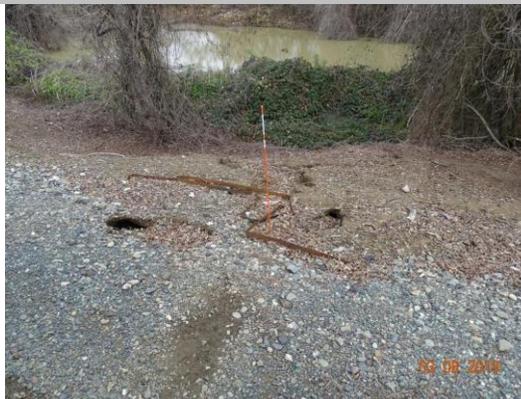
Photo 1 of 1 : SP\_2019\_RD0827\_187\_17\_20190311\_00018.jpg

LM Start	<b>1.09</b>	Rating **	M	Issue No.	<b>17</b>
LM End	<b>1.09</b>	Issue Type +	Ma	Location *	WS
Category	Earthen Levee		GPS Latitude/Longitude		
			Start	End	
Item	Erosion / Bank Caving		38.663946°	38.663946°	
			-121.616453°	-121.616453°	
DWR ID	DWR_RD0827_01_s_2019_17				
Comment Code					
E2 : Schedule repair of erosion site prior to the next inspection.					
Inspector Comment					
Runoff site through rodent holes.

View of erosion on the waterside slope. Spring 2019.

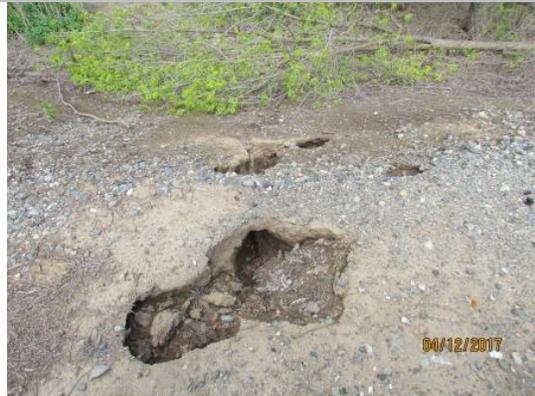
Photo 1 of 3 : SP\_2019\_RD0827\_187\_3\_20190304\_00001.jpg

LM Start	<b>1.12</b>	Rating **	M	Issue No.	<b>3</b>
LM End	<b>1.12</b>	Issue Type +	Ma	Location *	WS
Category	Earthen Levee		GPS Latitude/Longitude		
			Start	End	
Item	Erosion / Bank Caving		38.663542 °	38.663542 °	
			-121.616056 °	-121.616056 °	
DWR ID	DWR_RD0827_01_f_2016_3				
Comment Code					
E2 : Schedule repair of erosion site prior to the next inspection.					
Inspector Comment					
Erosion on the crown and waterside slope from runoff.

View of erosion on waterside levee slope. Spring 2017.

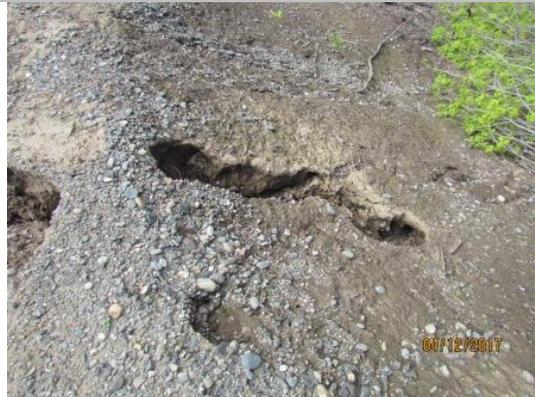
Photo 2 of 3 : SP\_2019\_RD0827\_187\_3\_20190304\_00002.jpg

Another view of erosion on levee slope. A hole on the waterside slope has widened due to runoff. Spring 2017.

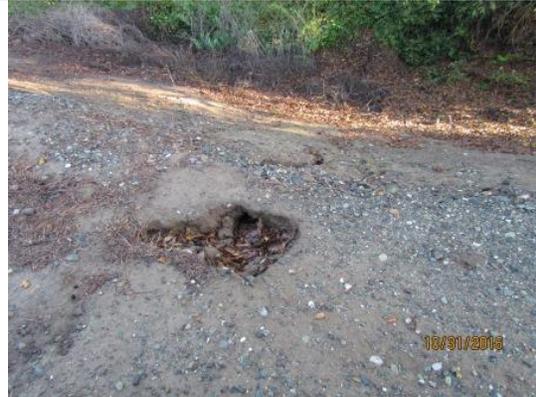
Photo 3 of 3 : SP\_2019\_RD0827\_187\_3\_20190304\_00003.jpg

LM Start	<b>1.12</b>	Rating **	M	Issue No.	<b>3 (cont)</b>
LM End	<b>1.12</b>	Issue Type +	Ma	Location *	WS
Category	Earthen Levee		GPS Latitude/Longitude		
			Start	End	
Item	Erosion / Bank Caving		38.663542 °	38.663542 °	
			-121.616056 °	-121.616056 °	
DWR ID	DWR_RD0827_01_f_2016_3				
Comment Code					
E2 : Schedule repair of erosion site prior to the next inspection.					
Inspector Comment					
Erosion on the crown and waterside slope from runoff.

View of erosion on crown continuing to WS slope. Fall 2016.

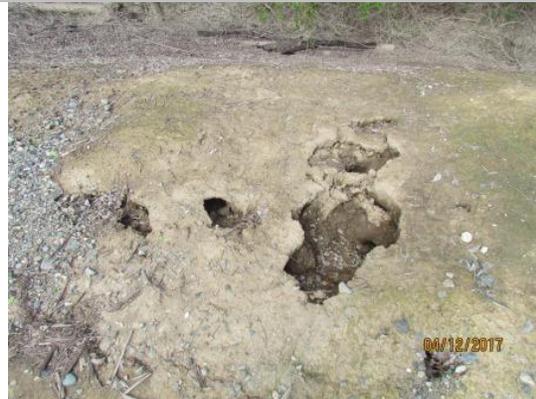
Photo 1 of 1 : SP\_2019\_RD0827\_187\_14\_20190304\_00011.jpg

LM Start	<b>1.14</b>	Rating **	A/W	Issue No.	<b>14</b>
LM End	<b>1.14</b>	Issue Type +	Ma	Location *	WS
Category	Earthen Levee		GPS Latitude/Longitude		
			Start	End	
Item	Erosion / Bank Caving		38.663377 °	38.663377 °	
			-121.615895 °	-121.615895 °	
DWR ID	DWR_RD0827_01_s_2017_14				
Comment Code					
E2 : Schedule repair of erosion site prior to the next inspection.					
Inspector Comment					
Minor erosion on waterside slope. Recommend monitoring

View of erosion on waterside levee slope. Spring 2017.

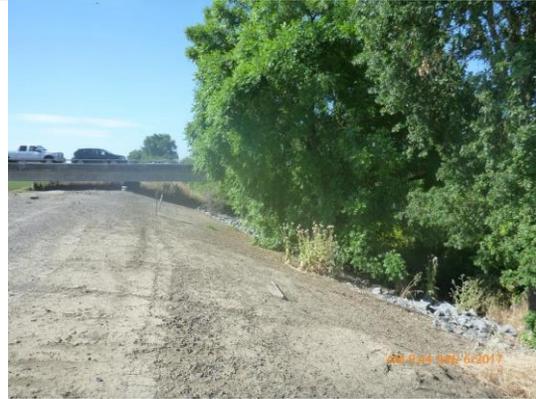
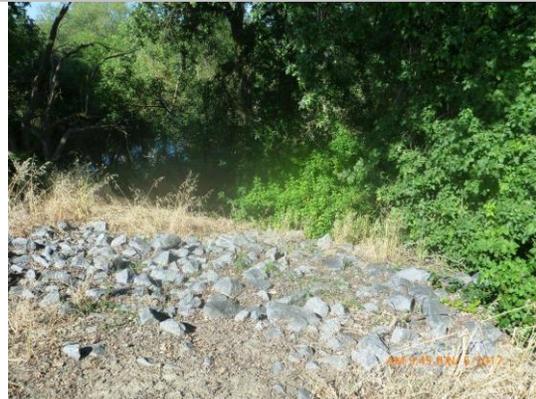
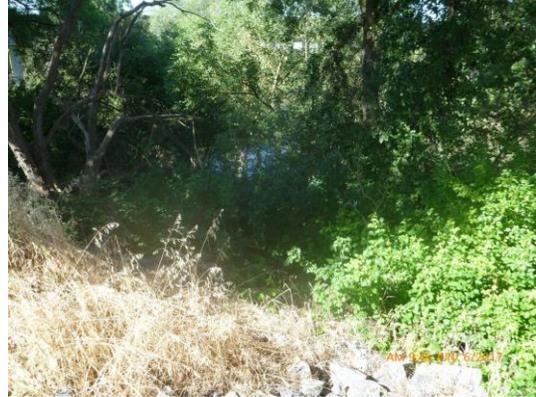
LM Start	<b>0.15</b>	Rating **	A/W	Issue No.	<b>10</b>
LM End	<b>0.16</b>	Issue Type +	Ma	Location *	
Category	Supplemental		GPS Latitude/Longitude		
			Start	End	
Item	2017 Storm Damage		38.674778 °	38.674583 °	
			-121.642806 °	-121.642722 °	
DWR ID	DWR_RD0827_02_f_2017_10				
Comment Code					
Inspector Comment					
Levee Evaluation Comments					
Description:					
Site ID No:200					
Site Designation:RD 827-02					
Repair Type: Erosion					
Rating:Area of Concern					
Field Date:6/6/2017					
Notes: no damage visible, ws armored with riprap

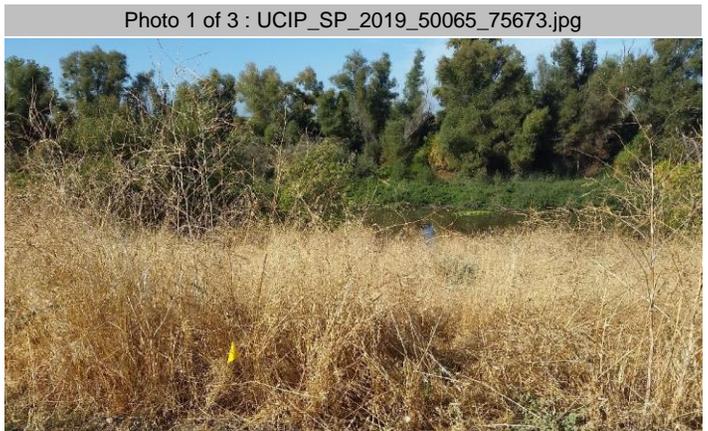
Item	DWR UCIP Field Study		38.663485 °	38.663485 °	
			-121.637021 °	-121.637021 °	
DWR ID	24844				
Comment Code					
Inspector Comment					
<p>FS_ID:50065                  DS_ID:24844                  EP_NO: 17403                  Repair Type: Non-Urgent                  Crossing Status: Indicator Found                  UCIP Comments: 9/27/2016 Need to coordinate with Greg Lucas (gregory.lucas@crc.com) with California Resources Corporation to determine if line will be brought online. Crossing was downgraded from Urgent to Non-Urgent--new owner has not brought the pipe online. New owner will need to update permit name and if line becomes active markers will be required per Title 23. (DWR UCIP - omagana)9/02/2016 Meet with Jimmy Preston from California Resources Corporation at site. Alignment of crossing was confirmed (new location is approximately 290 feet upstream from previous point)--report has been updated. Pending action -- Name Change (DWR UCIP - omagana)9/01/2016 Email was sent to Greg Lucas from California Resources Corporation with an updated UCIP detailed report and Central Valley Flood Protection Board (CVFPB) name change form. New owner will need to update permit information with the CVFPB to be compliant with Title 23 requirements. (DWR UCIP - omagana)8/31/2016 New owner--California Resources Corporation. Gas line is currently not in use.Meet with Greg Lucas, Assistant Production Coordinator from California Resources Corporation and Steve Stein from Noble Methan, Inc. to clarify current status of crossing and determine crossing alignment. Gas well is part of the gas line appurtenances. Gas line alignment is still pending--California Resources Corporation will send out someone to confirm alignment. Crossing is missing markers, if line becomes active markers will be needed on both the WS and LS to comply with Title 23--encouraged owner to contact CVFPB. (DWR UCIP - omagana)8/30/2016 Coordinating with AA Production Services, Inc. to determine location of where crossing goes through levee. It appears that the gas well located on LS is not part of this crossing. (DWR UCIP - omagana)8/04/2016 Meet with Bill Mattos, representative of RD 827, and he took me to the gas well visible from levee crown. Mr. Mattos was unable to confirm if gas well and pipeline that goes through the levee were connected.3/18/2014 No markers visible on either banks. Need to contact owner to determine status of crossing. Need date of last inspection and confirmation that crossing is still in operable condition. (DWR UCIP - omagana)                  FIELD_STRUCT_DESC: [Hanks 34-2] 2.375-inch steel natural gas pipe through the levee, 30 feet below the crown and under (bored) Tule Canal. Gas well is located on the landside (LS) approximately 994 feet from levee crown. California Resources Corporation acquired AA Production Services, Inc. The new owner of the 2.375-inch gas pipe is California Resources Corporation. (2.375-inch line authorized under Permit No. 17403, 2001 - AA Production Services, Inc.)</p>

View of WS--Tule Canal.

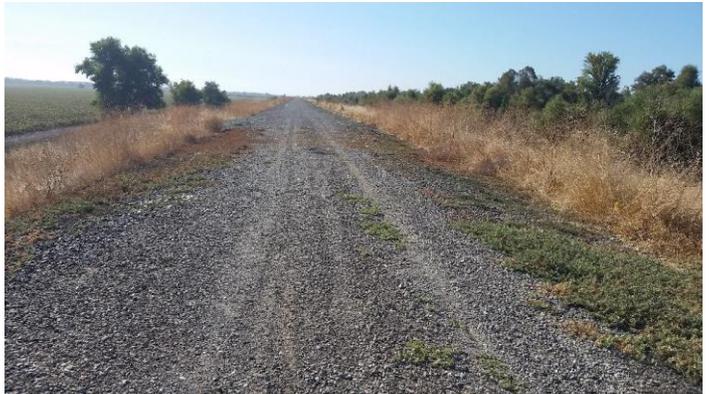
Photo 2 of 3 : UCIP\_SP\_2019\_50065\_75672.jpg

View of levee crown at crossing--yellow flag markers visible on both WS and LS shoulder.

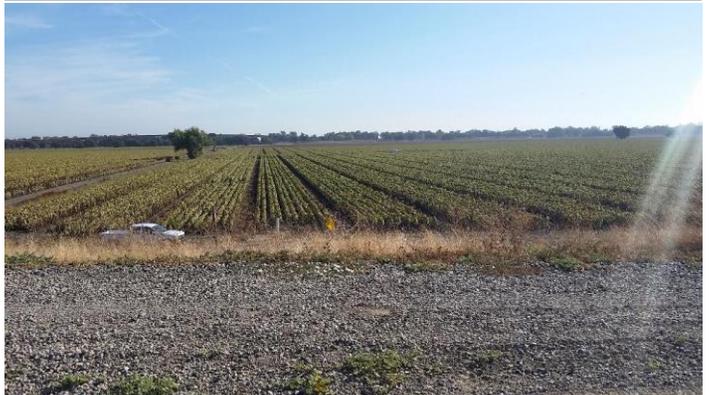
Photo 3 of 3 : UCIP\_SP\_2019\_50065\_75671.jpg

View of LS.

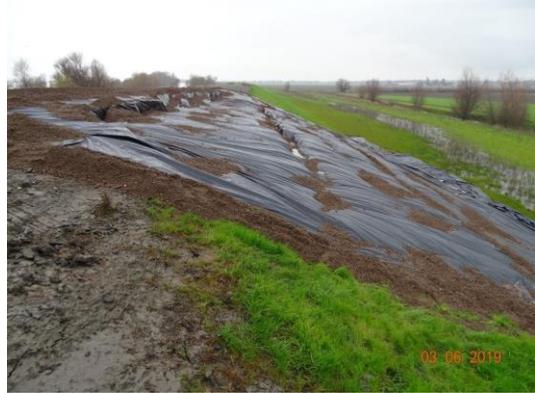
Photo 1 of 1 : SP\_2019\_RD0827\_188\_8\_20190311\_00026.jpg

LM Start	<b>1.94</b>	Rating **	M	Issue No.	<b>8</b>
LM End	<b>1.96</b>	Issue Type +	Ma	Location *	LS
Category	Earthen Levee		GPS Latitude/Longitude		
			Start	End	
Item	Slope Stability		38.652232 °	38.651939 °	
			-121.627264 °	-121.627088 °	
DWR ID	DWR_RD0827_02_s_2019_8				
Comment Code					
S1 : Repair slope instability.					
Inspector Comment					
100' sloughing section on the landside slope. Exposed scarp is approximately 1' at the worst section. LMA placed visqueen over the issue.

View of sloughing on the landside slope. Spring 2019.

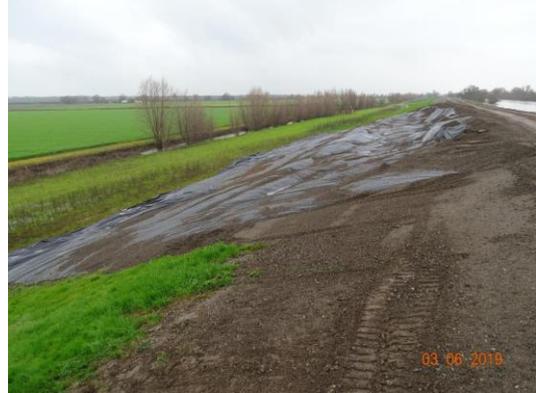
Photo 1 of 1 : SP\_2019\_RD0827\_188\_7\_20190311\_00025.jpg

LM Start	<b>2.09</b>	Rating **	U	Issue No.	<b>7</b>
LM End	<b>2.14</b>	Issue Type +	Ma	Location *	LS
Category	Earthen Levee		GPS Latitude/Longitude		
			Start	End	
Item	Slope Stability		38.650245 °	38.649602 °	
			-121.626036 °	-121.625646 °	
DWR ID	DWR_RD0827_02_s_2019_7				
Comment Code					
S1 : Repair slope instability.					
Inspector Comment					
Sloughing from 2019 storm damage. LMA placed visqueen over the issue.

View of sloughing on the landside slope. Spring 2019.

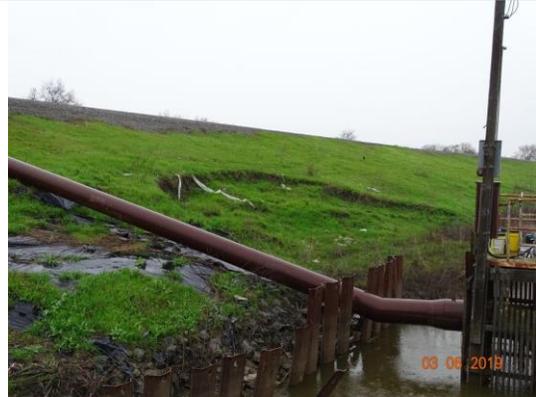
Photo 1 of 4 : SP\_2019\_RD0827\_188\_13\_20190311\_00024.jpg

LM Start	<b>2.72</b>	Rating **	M	Issue No.	<b>13</b>
LM End	<b>2.73</b>	Issue Type +	Ma	Location *	
Category	Supplemental		GPS Latitude/Longitude		
			Start	End	
Item	2017 Storm Damage		38.642139°	38.642028°	
			-121.620750°	-121.620667°	
DWR ID	DWR_RD0827_02_f_2017_13				
Comment Code					
Inspector Comment					
Levee Evaluation Comments Description: Site ID No:199 Site Designation:RD 827-01 Repair Type: Erosion Rating:Area of Concern Field Date:6/6/2017 Notes: landside. Sloughing on the landside slope near pump. Movement has stabilized and the LMA will be constructing a setback levee within the next 3 years. Recommend monitoring.

View of sloughing on the landside slope. Spring 2019.

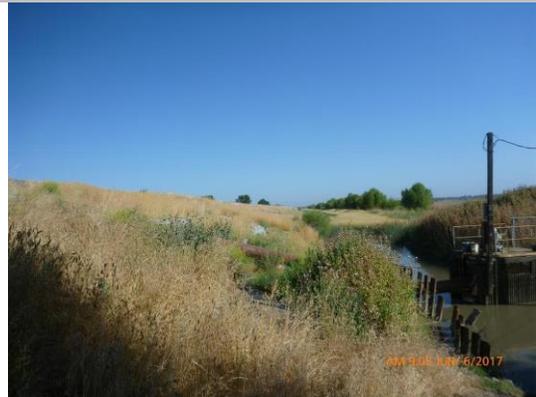
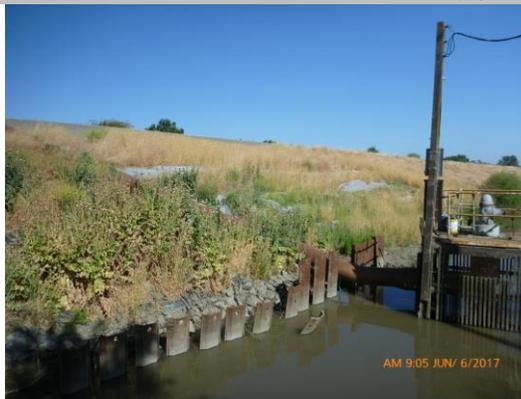
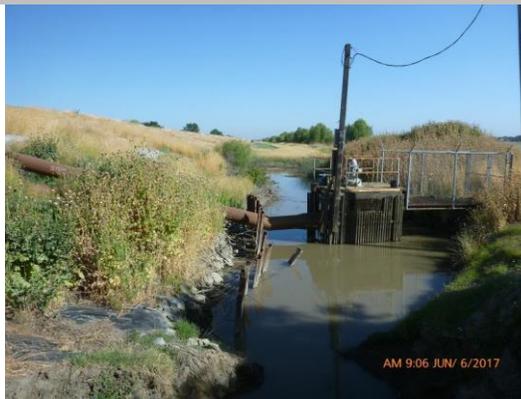
LM Start	<b>2.72</b>	Rating **	M	Issue No.	<b>13 (cont)</b>
LM End	<b>2.73</b>	Issue Type +	Ma	Location *	
Category	Supplemental			GPS Latitude/Longitude	
				Start	End
Item	2017 Storm Damage			38.642139°	38.642028°
				-121.620750°	-121.620667°
DWR ID	DWR_RD0827_02_f_2017_13				
Comment Code					
Inspector Comment					
Levee Evaluation Comments Description: Site ID No:199 Site Designation:RD 827-01 Repair Type: Erosion Rating:Area of Concern Field Date:6/6/2017 Notes: landside. Sloughing on the landside slope near pump. Movement has stabilized and the LMA will be constructing a setback levee within the next 3 years. Recommend monitoring.

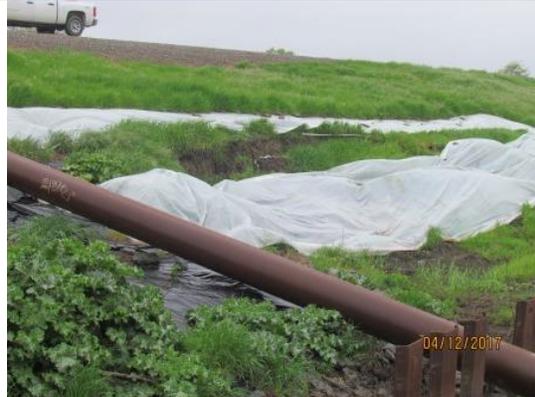
Photo 1 of 2 : SP\_2019\_RD0827\_188\_14\_20190304\_00010.jpg

LM Start	<b>2.72</b>	Rating **	A/W	Issue No.	<b>14</b>
LM End	<b>2.72</b>	Issue Type +	Ma	Location *	LS
Category	Earthen Levee		GPS Latitude/Longitude		
			Start	End	
Item	Slope Stability		38.642018°	38.642018°	
			-121.620944°	-121.620944°	
DWR ID	DWR_RD0827_02_s_2017_14				
Comment Code					
S1 : Repair slope instability.					
Inspector Comment					
Sloughing on the landside slope near pump. Movement has stabilized.

View of sloughing and visqueen on landside levee slope. Spring 2017.

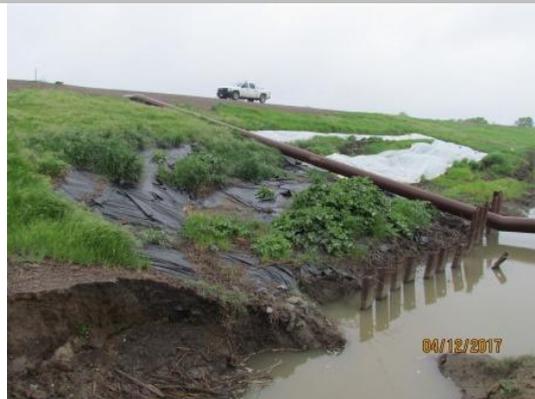
Photo 2 of 2 : SP\_2019\_RD0827\_188\_14\_20190304\_00011.jpg

Additional view of sloughing on landside levee slope. Spring 2017.

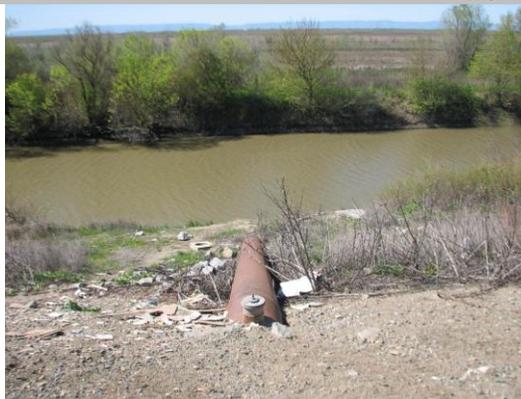
Photo 1 of 3 : UCIP\_SP\_2019\_33032\_59778.jpg

Item	DWR UCIP Field Study		38.641633 °	38.641633 °	
			-121.620725 °	-121.620725 °	
DWR ID	21169				
Comment Code					
Inspector Comment					
FS_ID:33032 DS_ID:21169 EP_NO: 5611 Repair Type: Non-Urgent Crossing Status: Found UCIP Comments: Crossing appears to have been removed and replaced under maintenance back in 2008. No permit has been found--need to contact owner to obtain additional information about replacement. FIELD_STRUCT_DESC: [RD No. 827 Pumping Plant] 22-inch (not 24-inch as mentioned in desk study) steel drainage pipe through the levee, 8 feet below the crown. Corrugated metal cutoff wall around pipe at center of levee. Siphon breaker on waterside (WS) slope. Flap gate on WS end. Pipe is exposed along WS slope. (portion of pipe was removed and replaced, from landside to waterside shoulder, under Permit No. 5611 (1968)). [Additional Reference(s): DWR Levee Logs, 2005. USACE Sacramento O&M Manual Unit No. 122 Part No. 1, August 1955, (Station 3+75)] FS Date: 3/18/2014

Pipe exposed on waterward side.

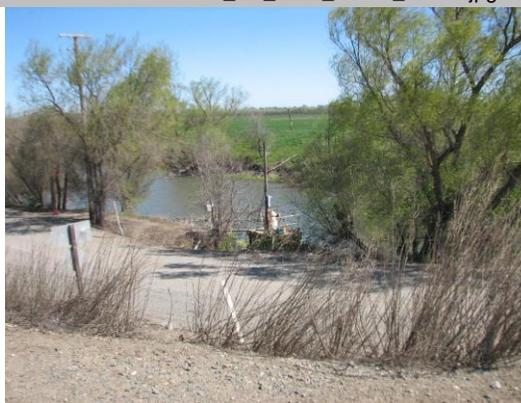
Photo 2 of 3 : UCIP\_SP\_2019\_33032\_59777.jpg

Pump station located on landward side.

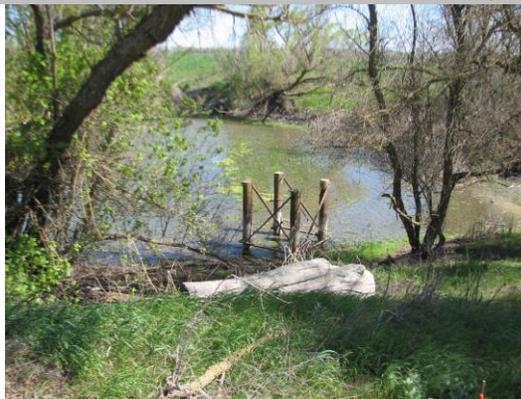
Photo 3 of 3 : UCIP\_SP\_2019\_33032\_59776.jpg

Item	DWR UCIP Field Study			38.641633 °	38.641633 °
				-121.620725 °	-121.620725 °
DWR ID	21169				
Comment Code					
Inspector Comment					
FS_ID:33032 DS_ID:21169 EP_NO: 5611 Repair Type: Non-Urgent Crossing Status: Found UCIP Comments: Crossing appears to have been removed and replaced under maintenance back in 2008. No permit has been found--need to contact owner to obtain additional information about replacement. FIELD_STRUCT_DESC: [RD No. 827 Pumping Plant] 22-inch (not 24-inch as mentioned in desk study) steel drainage pipe through the levee, 8 feet below the crown. Corrugated metal cutoff wall around pipe at center of levee. Siphon breaker on waterside (WS) slope. Flap gate on WS end. Pipe is exposed along WS slope. (portion of pipe was removed and replaced, from landside to waterside shoulder, under Permit No. 5611 (1968)). [Additional Reference(s): DWR Levee Logs, 2005. USACE Sacramento O&M Manual Unit No. 122 Part No. 1, August 1955, (Station 3+75)] FS Date: 3/18/2014

Reminise piles located on landward side.
